PRELIMINARY REPORT ON SEISMIC TESTING OF A FULL-SCALE SIX-STORY STEEL BUILDING

By
DOUGLAS A. FOUTCH
SUBHASH C. GOEL
CHARLES W. ROEDER

UNIVERSITY OF ILLINOIS
AT URBANA-CHAMPAIGN
URBANA, ILLINOIS
NOVEMBER 1986

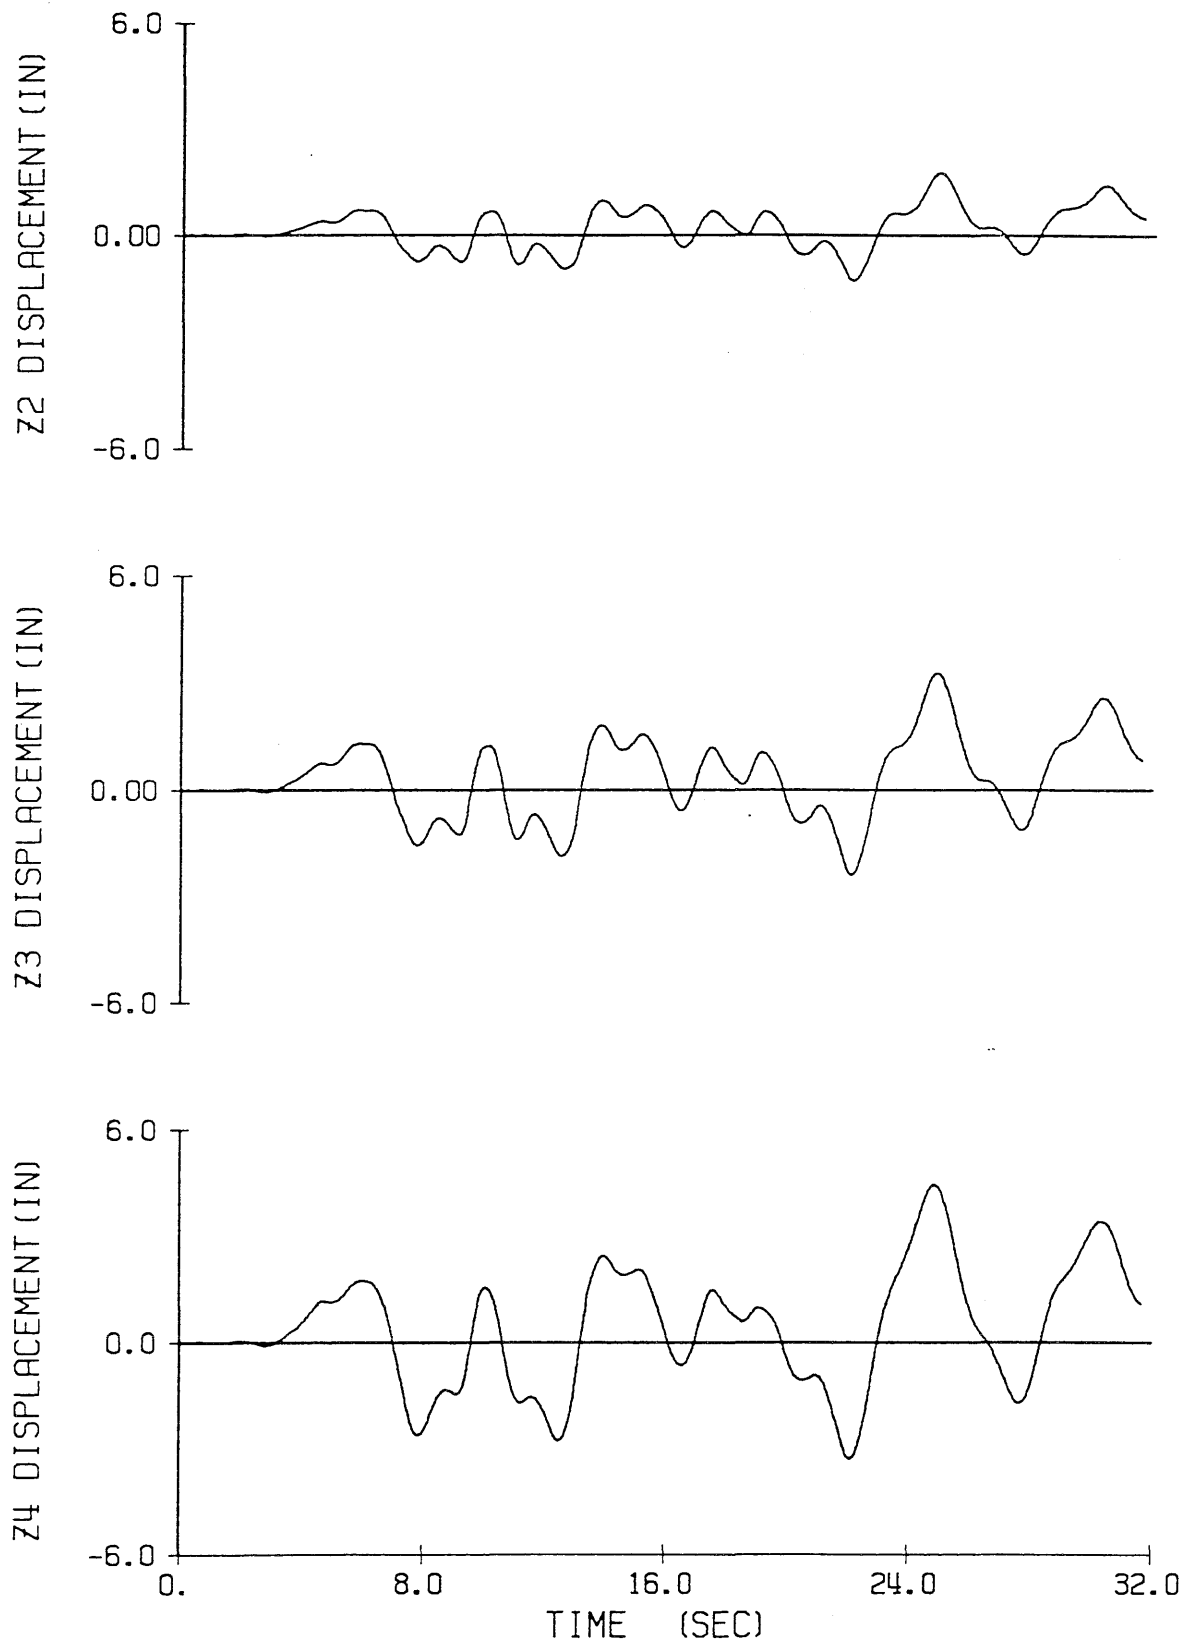
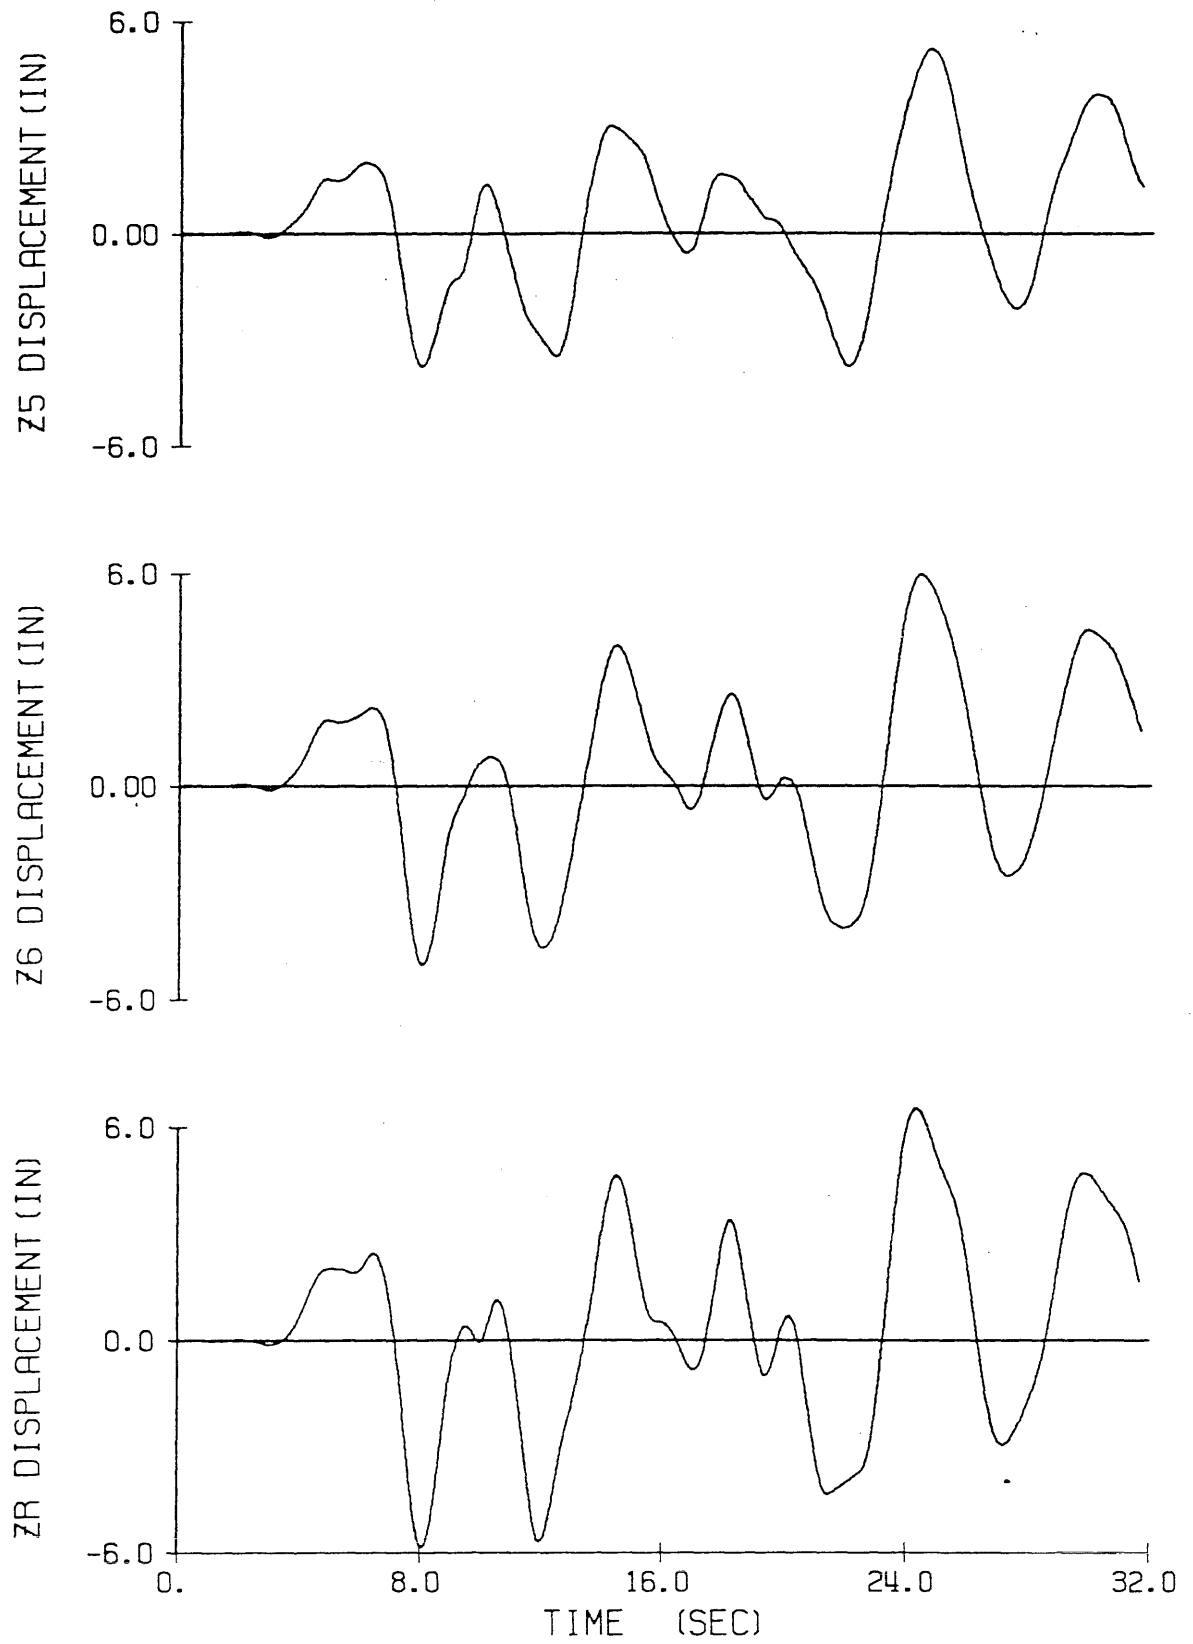
Fig. 6.1 Floor displacements vs. time for the Phase III tests

The building was subjected to the 1940 El Centro Earthquake with 350 gal peak acceleration. The time dependent floor displacements are shown in Fig. 6.1. The story shear vs. story displacement for the first two stories are shown in Fig. 6.2. These plots show that the structure was more flexible and somewhat weaker as expected, but the inelastic behavior was stable. It is quite remarkable that after being subjected to several major earthquakes, the frames were still performing well. The maximum base shear was approximately 1.23 MN (278 kips) which was approximately 19% of the total weight of the structure. This percentage
